Reducing Riser/Meter Set Corrosion to Lower Lifecycle Costs

Project Description

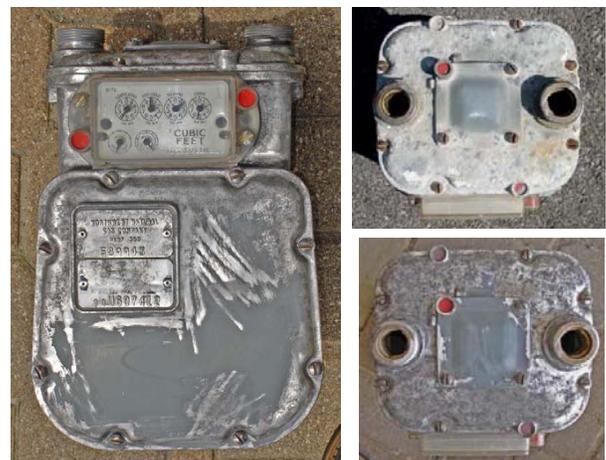
At right, top-down view of meter uncoated (top) and coated (bottom). At left, a fully coated meter.

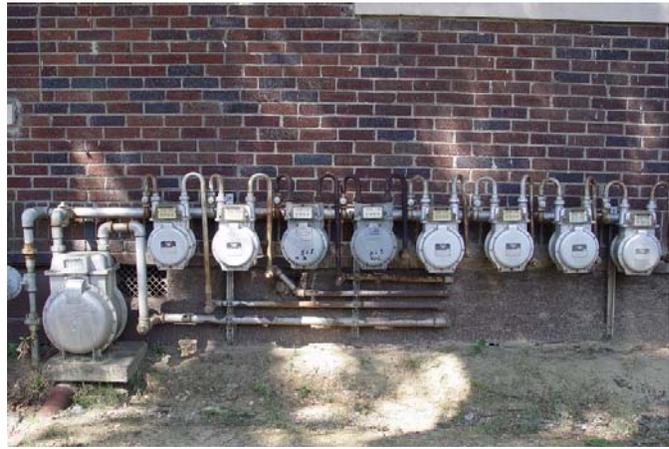
Investigators researched enhanced methods to clean, prepare, and coat exposed equipment to reduce corrosion and extend system life.
