# Assessment of Acceptable Siloxane Concentrations in Biomethane

Biomethane from various waste products could provide consumers with a significant source of “green” renewable energy. For this project, a study was conducted into siloxane – one of the potential constituents in biomethane – to assess its influence on health, the environment, and gas-fired appliances.

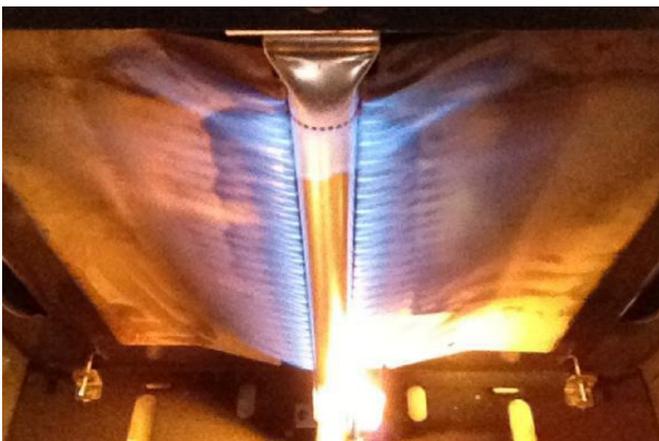
Images of the water-heater flame were taken weekly to document any visual changes. At left is the baseline flame image.

Periodic analysis of the flue gas showed no significant changes to carbon dioxide and carbon monoxide during the length of testing. Internal inspection of the water heater showed significant accumulation of silica deposits on all surfaces in contact with the flue gas, and a large deposit of material on top of the burner. Analysis of this material showed it to contain a mixture of silica and iron, most likely due to rust.

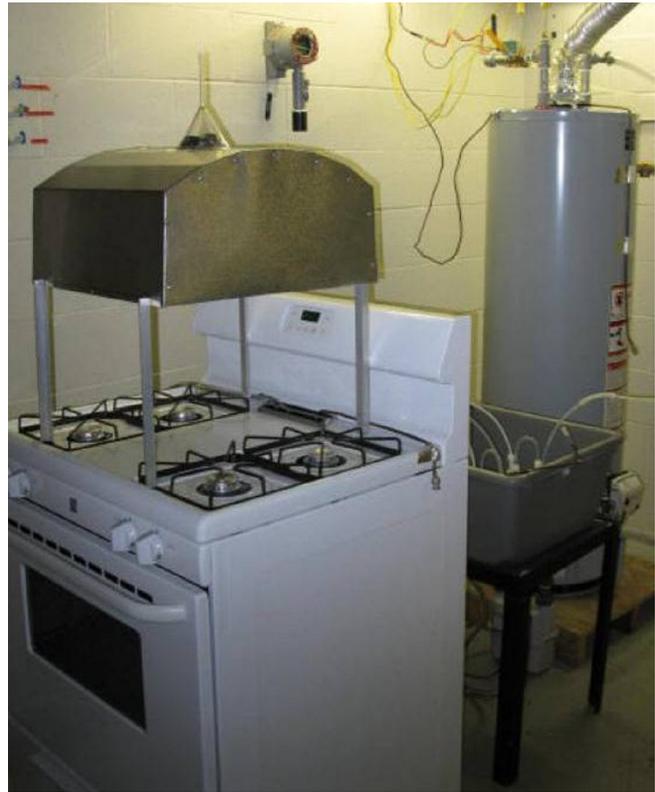
*Laboratory testing.*

In 2012, testing began with a water heater for the vented appliance and an oven for the unvented appliance with siloxane spiking of the fuel gas. The units operated Monday through Friday for eight hours per day. During the testing period, samples of the fuel gases were periodically analyzed to monitor siloxane concentrations. Flue gas samples were also analyzed to monitor changes in component levels, particularly carbon monoxide and carbon dioxide. Air samples were taken above the oven and monitored for particulates, and coupons were placed inside the oven to monitor surface accumulation.
