Composite Repair Wrap for Polyethylene Systems

Researchers are evaluating a new composite pipe wrap system for the repair of mechanically damaged polyethylene gas pipe. The repair system has the potential to lower repair costs, reduce repair times, and minimize service disruptions.

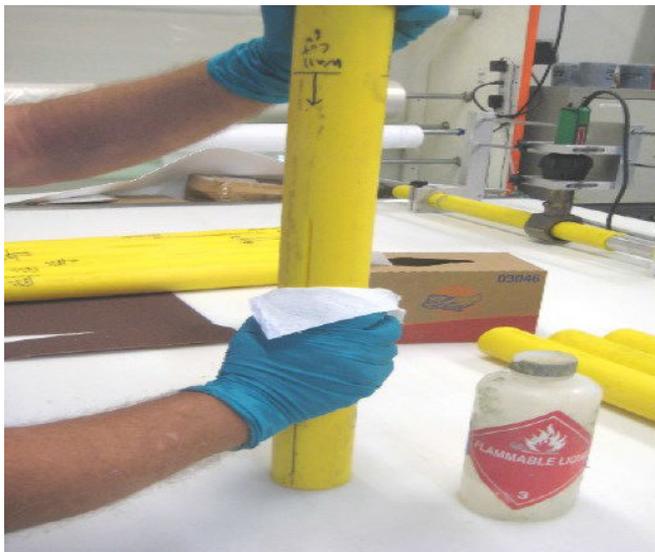
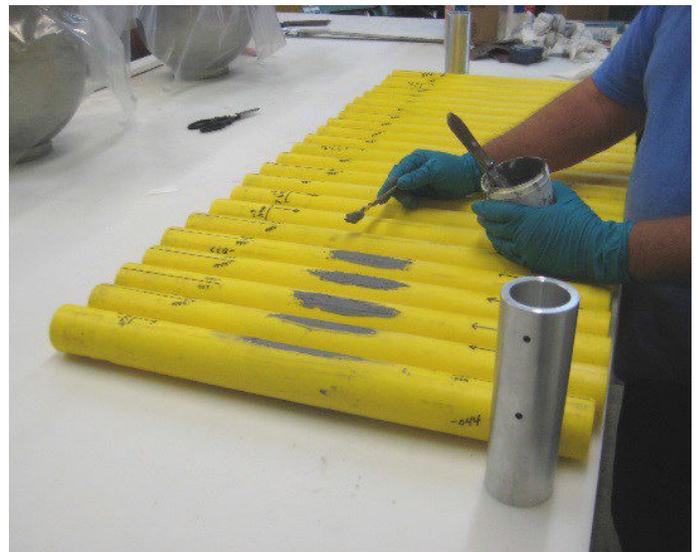
Sample preparation.

Specimens were notched during preparation with generally four-inch-long longitudinal notches milled in the center of the pipe specimen to a depth of 80% of the measured minimum wall thickness of the specimen. Repair-system applications were conducted while the pipe was both heated and unheated.
